German weavers embrace automatic on-loom inspection

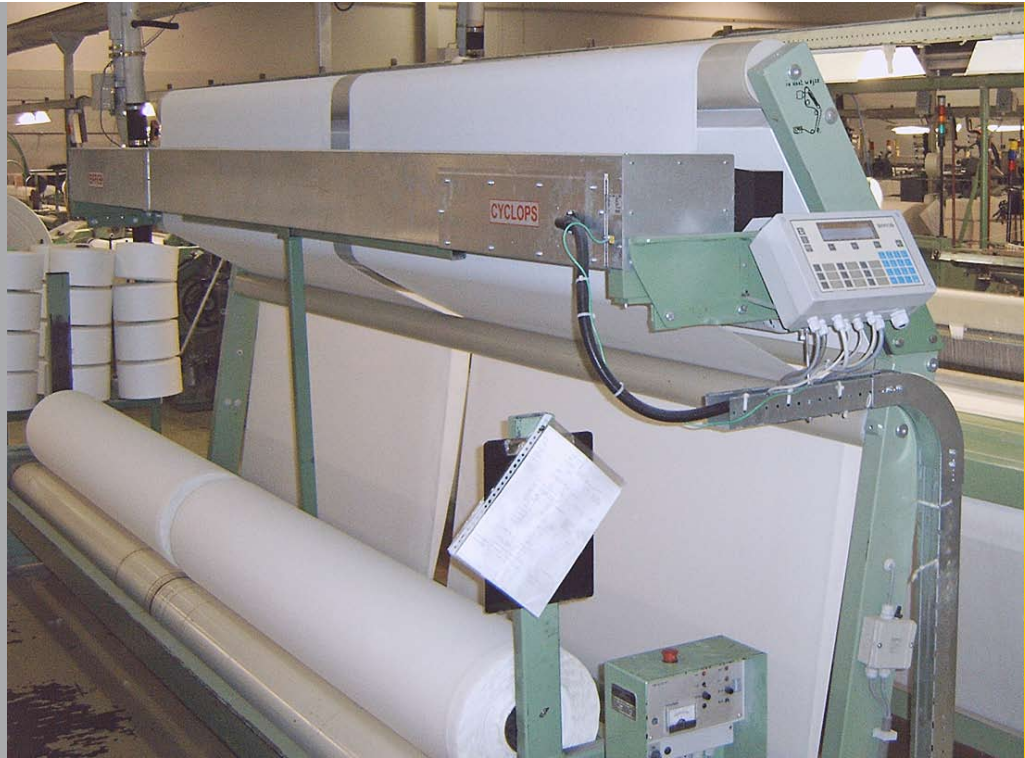
Fig. 1: Cyclops is mounted on the off-loom take up and uses one or two moving camera units scanning the fabric for possible defects. A data unit serves as interface between Cyclops and the loom.

BMS's automated on-loom inspection system was one of the systems shown at the above referenced ITMA's. Unlike other proposed solutions BMS positioned its Cyclops system (Fig. 1) not only as a defect detection system but also as a defect data entry system for its quality management software system called QUALIMASTER. The combination Cyclops and QUALIMASTER allowed processing the defect data so that cloth rolls could be automatically graded. For the identification of the cloth rolls a link with the monitoring system was established and this allowed label printing with an automatic feed back message for the ERP system containing all quality related data of the doffed cloth roll. Quickly it became abundantly clear that an automatic on-loom inspection system cannot be

The speed of the moving camera has quadrupled, offering a 100% inspection coverage. The scanner is now available for widths up to 560 cm featuring a dual camera approach for such wide looms.

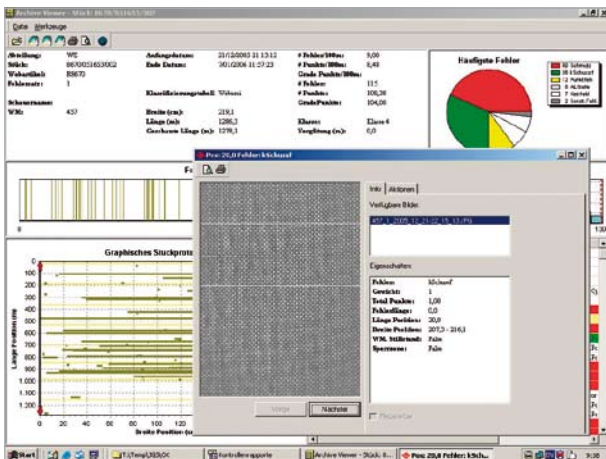
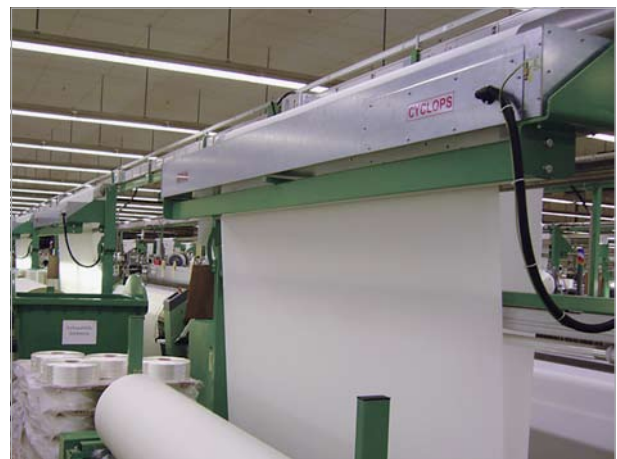
Fig. 3: QualiMaster generates a piece map for each individual piece inspected by Cyclops, showing all defects with their locations. For each defect, a picture is stored in the database.

The system generates a piece map showing the defect location in the fabric and for each defect a picture is available (Fig. 3). This gives quality control management a precise overview of the quality of each woven piece. All Cyclops units are connected to BMS's QUALIMASTER system, which makes quality information available in real time. Further Anton Cramer also uses BMS's WEAVEMASTER system for monitoring and planning. The 40 Cyclops have been installed in 2005 and are in operation in a 24 hour 7 days a week schedule. The scanners proved to be reliable. Anton Cramer experienced an important reduction in quality complaints, proving that off quality fabric is greatly reduced and also that the automated inspection is a trustworthy tool.
